# **System 9740™ Software Upgrade**

**CM9740-UPG-8312**

**C1547M (7/03)**

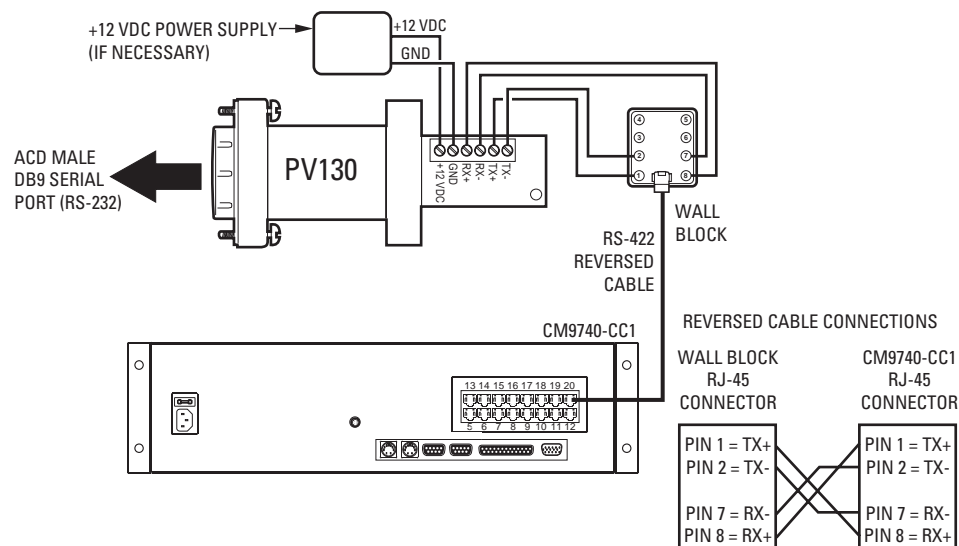
**Figure 6.** ACD DB9 to CM9740-CC1 RJ-45 Connection

To connect an ACD DB9 port to a CM9740-CC1 RJ-45 port, refer to Figure 6 and do the following:

**NOTE:** The numbering of the screw terminals on the wall block shown in Figure 6 applies to the Pelco RJ-45 wall block. A wall block purchased from a supplier other than Pelco may have a different numbering scheme.

4. Connect RX- on the converter to terminal 7 (RX-) on the wall block.
5. Connect TX+ on the converter to terminal 1 (TX+) on the wall block.
6. Connect TX- on the converter to terminal 2 (TX-) on the wall block.
7. Connect the wall block to an RJ-45 port of the CC1 using an RJ-45 reversed cable.
